# PIC18C601/801

## PIC18C601/801 Rev. C0 Silicon/Data Sheet Errata

The PIC18C601/801 parts you have received conform functionally to the Device Data Sheet (DS39541**A**), except for the anomalies described below.

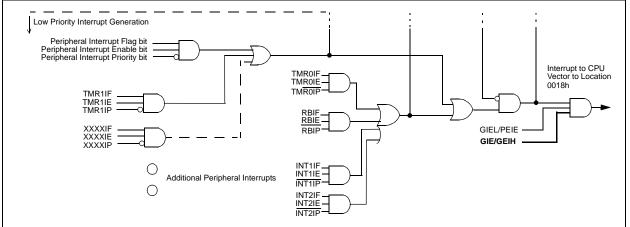
#### FIGURE 1: INTERRUPT LOGIC (EXCERPT)

The operation of the GIE/GIEH bit (INTCON<7>) is clarified as follows: when the bit is cleared, all interrupts are disabled. This is regardless of the state of the IPEN bit (RCON<7>), the priority of the interrupt, or whether or not the interrupt is unmasked. This varies from the original description, in which clearing the bit when IPEN = '1'would only disable high priority interrupts.

Also, the interrupt logic funnel shown in Figure Figure 1 of the Device Data Sheet is amended with the addition of a GIE/GIEH control line, as shown in Figure 1 (new material in **bold line**).

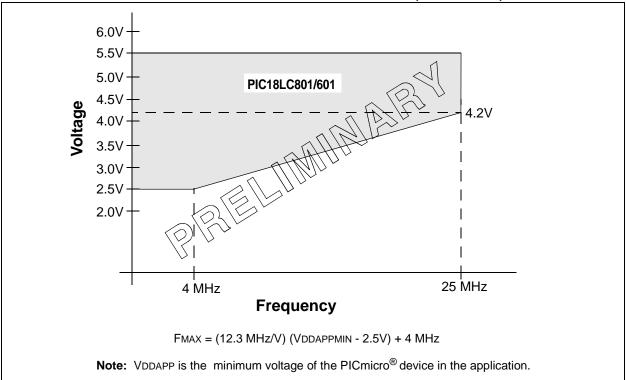
#### FIGURE 2: PIC18LC601/801 VOLTAGE-FREQUENCY GRAPH (INDUSTRIAL)

The minimum value for parameter specification number D001 (VDD) for extended voltage range devices has changed from 2.0V. The new value is shown in Table 3.

Because of this change, the voltage vs. frequency graph for extended voltage range devices has been modified. Figure 22-2 of the Device Data Sheet is replaced with Figure 2, below. This also clarifies that the graph refers to extended voltage range ("LC") devices.
